PWR2011-6767

Recent Regenerative Airheater Improvements at HECO Kahe Point, Oahu
Section 6D: Innovations of Maintenance Technologies and Practices

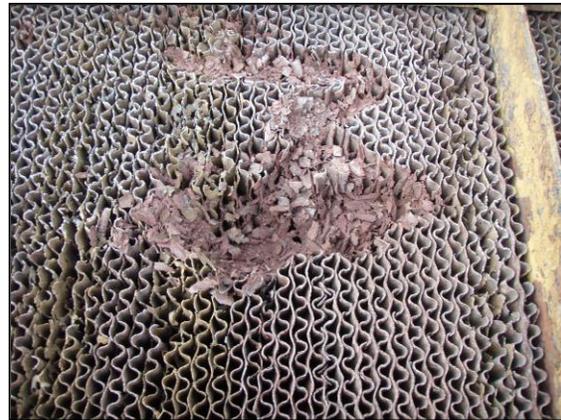
Photo No. 1

During the 2009, Kahe 2 over-haul, the cold end and cold intermediate baskets were replaced while the hot and hot intermediates were cleaned and inspected. It was noted at that time that the hot and hot intermediates were degrading and plans for replacement were put into place. It should be noted that these hot and hot intermediate baskets had been inspected many times over the years and appeared to be in good condition during those inspections.

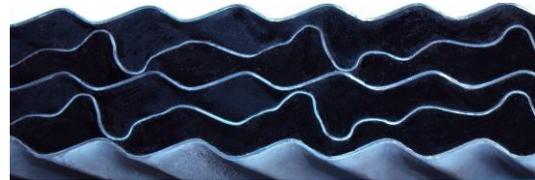
Photo 2, CU element

Photo 3, DU element

Following the testing and analysis completed after the Kahe Unit 2 overhaul in 2009, HECO engineers put out an RFP for new hot and hot intermediate baskets. After review of bidders HECO selected Paragon Airheater Technologies to supply the new baskets. Paragon worked with HECO to understand long standing problems and to come up with engineered solutions tailored to HECO's specific needs. Rather than propose a "cookie cutter" duplicate of the element style that had been installed in the hot intermediate and hot end layers of the air heater, Paragon recommended replacing the CU style element that had been utilized in these layers, with a more appropriate DU design in order to match Kahe Unit 2's operating parameters.

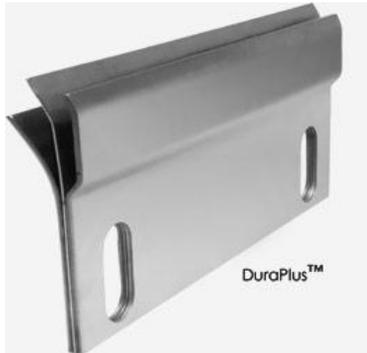
A cost effective and simple method for reducing air heater leakage is replacement of the original equipment type air heater seals with newer design high performance full contact radial seals and progressively interlaced circumferential/bypass seals- also designed for flexibility under contact - such as those shown here (*supplied by Paragon Air Heater Technologies*). Full contact seals have demonstrated the ability to reduce air heater leakage by 50% or more in many airheaters when they have replaced original equipment type seals commonly found today on most air heaters. An example of a high performance full contact radial seal (DuraPlus™) is shown in Figure 4.

In comparison with an original design seal, which is really a rigid “proximity” air dam, the full contact seal is constructed to maintain a continuous, but flexible contact with the sealing plate at all times, effectively eliminating the main path for radial seal leakage. These seals provide additional leakage reduction benefits because they are capable of maintaining full contact even when there is unevenness and distortion in the sealing surfaces (sector plates), as is commonly found in older air heaters. These “distortion gaps” can be a significant contributor to the high leakage rates found in most old air heaters.

Figure 4, DuraPlus™ High Performance Seal

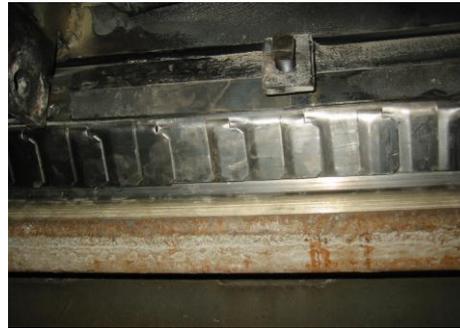
The high performance circumferential seals (DuraFlex™) shown in Figure 5 have progressively interlaced structural design that provides both flexibility and resistance to tearing,

which allows the seals to operate in contact with the perimeter sealing surface without being damaged, thus minimizing the gaps and leakage openings in comparison to original style seals.

Figure 5, Circumferential Seal
